PANGIL RIVER PROFILE

I. Description of the Area

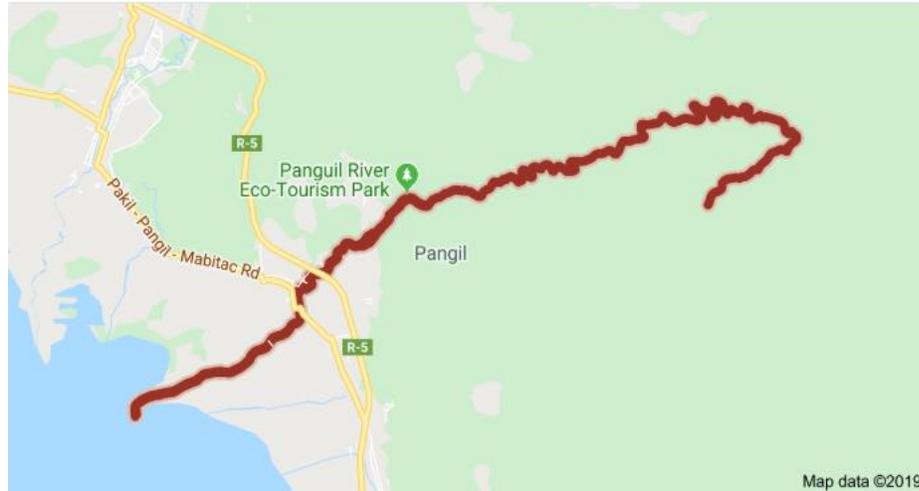
Figure 3. Pangil River Location Map
(Image source: Google Maps 2019)

The river lies at the southern tip of the Sierra Madre Mountain range (DILG, undated). It used for domestic, agricultural, ecotourism in the Municipality of Pangil, and has seen potential for other economic uses such as hydropower (DILG, undated). It is also one of 22 River tributaries of Laguna de Bay (see Figure 3).

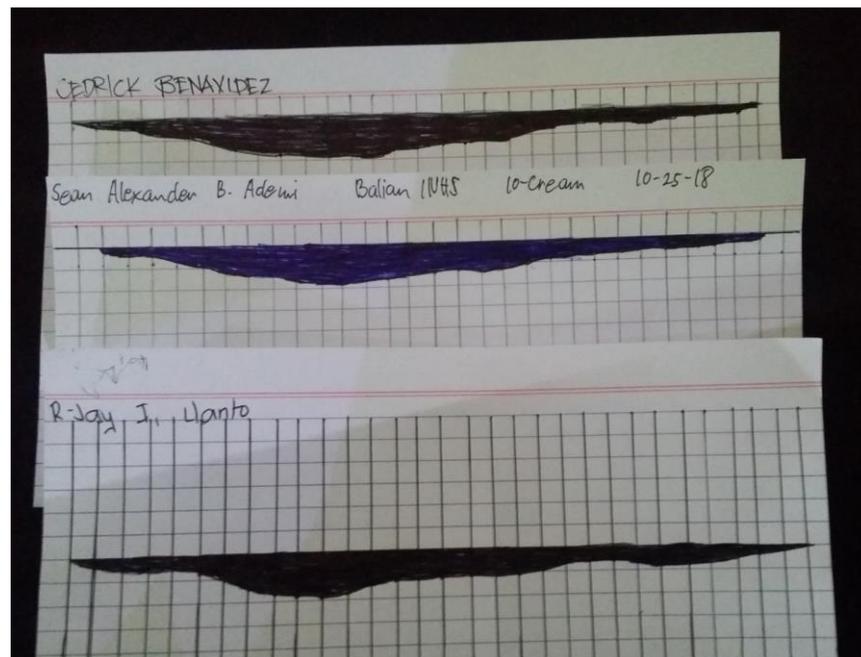
Figure 4. Sample of plotted cross-sectional measurement of the river

Figure 4 shows the plotted cross-sectional measurement of the river. The measurement came from the Hydrology assessment of the River.

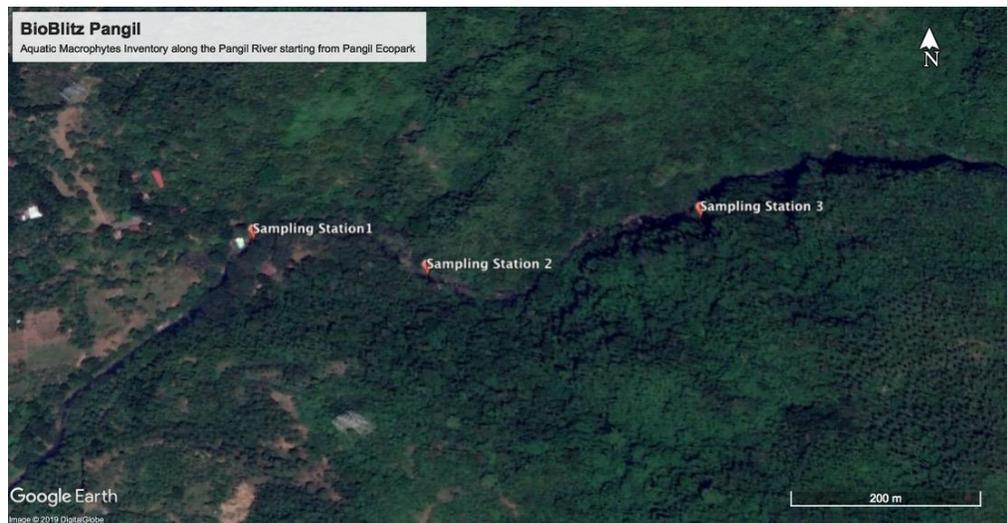
Figure 5. Sampling sites for Flora Inventory at Pangil River.

The three sampling stations were chosen along the river within the Pangil River and Ecopark Area. Sampling Station 1 is located near the swimming pool and picnic area. As such, this segment of the river is the most anthropogenically disturbed among the three sites. Forest canopy above the river is open, allowing sunlight to enter. Sampling Station 2 is located about 200m from the main activity/swimming pool area. Forest canopy in this area is a bit closed, thus giving a cooler feel compared to Station 1. There are no more picnic huts in this area, but traces of picnic activities are observed in the river banks. Sampling site 3 is located within the restricted area of the Ecopark trail leading towards the waterfalls area. Forest canopy in this area is also a bit open. It can be noted that aside for the bamboo bridge constructed, there are hardly any anthropogenic disturbance observed.

Based on the data gathered, more plants were identified in Station 1 compared to the other sampling sites. The plants were composed mainly of introduced or exotic plant species that are mainly ornamental in nature and are pioneer species. Lower species richness was documented at stations 2 and 3. This can be attributed to the area being less disturbed thus allowing stabilisation of existing species. More native species and late successional species were observed in Stations 2 and 3.
